Manhole Inspection Summary

Manhole # S13CC1012MH

Location Address: **3911 TOWANDA AVE**

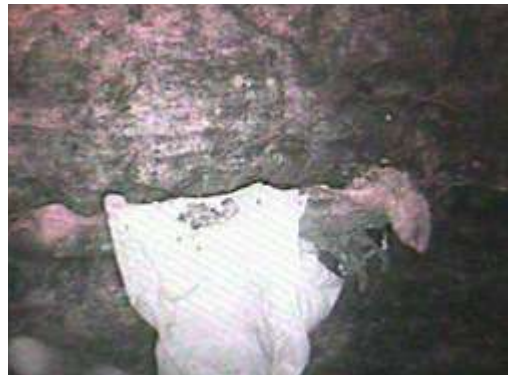
Defect 1

Count: **8** Missing: **0** ☒ **Corroded**

☒ **Evidence Of Surcharge** Depth: **6** (ft.) ☐ Active Surcharge Present

SURCHARGE, CORRODED STEP

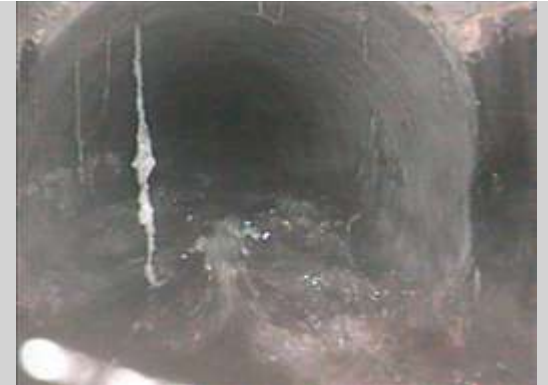
12 O'Clock Outflow

24 in. Circular Gravity Sewer
Pipe Out @ 12 O'Clock

Pipe Height: **24** (in.) Rod and Bar (Angled)
Pipe Material: **PVC** ☐ Pipe Lined
Invert Depth: **14.85** (ft.) Flow Characteristics: **Turbulent**
Deposits: ☒ None ☐ Mud ☐ Sludge ☐ Debris ☐ Grease
Silt Depth: (in.) Deposits Extent:
Infiltration: **None** Pipe Seal Cond: **Sound**

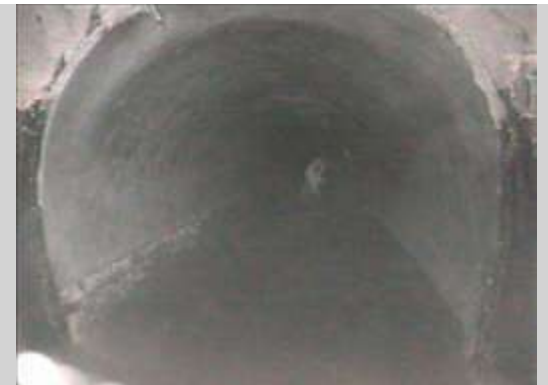
6 O'Clock Inflow

24 in. Circular Gravity Sewer
Pipe In @ 6 O'Clock

Pipe Height: **24** (in.) Rod and Bar (Angled)
Pipe Material: **PVC** ☐ Pipe Lined
Invert Depth: **14.76** (ft.) Flow Characteristics: **Turbulent**
Deposits: ☒ None ☐ Mud ☐ Sludge ☐ Debris ☐ Grease
Silt Depth: (in.) Deposits Extent:
Infiltration: **None** Pipe Seal Cond: **Sound**
